Pursuing Changes on Sandy Beach Environment by using Geo-informatics: Case of Nakhodka Oil Spill incident

NOBUHIRO SAWANO

Abstract – Nakhodka oil spill happened in January 1997, more than 2,000 km of shoreline facing the Sea of Japan was contaminated by heavy oil. Soon after the oil stranded on the beach in Kaga city, more than 70 heavy construction machines were introduced for recovering oil. After the recovery works, about 1,800 m³ of “oiled sand” was made and most part of them was buried at the beach. Four years after the spill and recovery works, steep dune scarp have appeared and sand erosion occurred. These phenomena are thought to be brought about the deprivation of vegetation caused by the recovery works.

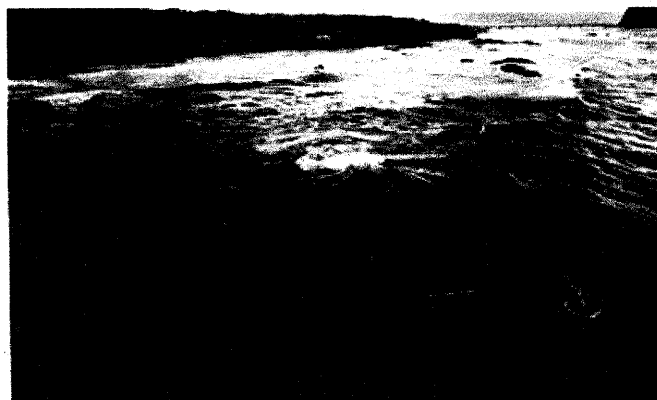
Figure 2. Bow section drifting toward Fukui Prefecture.
(Presented by Hokkuriku Chunichi Shinbun Co., Ltd.)

In addition to aging, poor ship management and inadequate loading, the final trigger was pulled by the fierce gale of the winter weather of the Sea of Japan. She could not bear the bending moment caused by 7 to 8m effective wave height and over 30m wind speed, she broke into two sections approximately 100 kilometers off Oki Island. Main section sank to the sea floor and bow section was drifting for five days about 250 kilometers, finally grounded at Mikuni Town, Fukui Prefecture (see Figure 1 and 2).

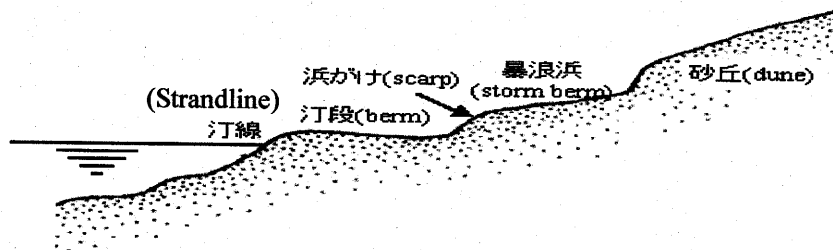
Fig. 4 Typical vertical structure of the sand beach facing the Sea of Japan

Originally, sand beaches in these areas have similar vertical structure shown in figure 4. Small tidal as to 40 cm can be considered as a main factor to develop such structure.

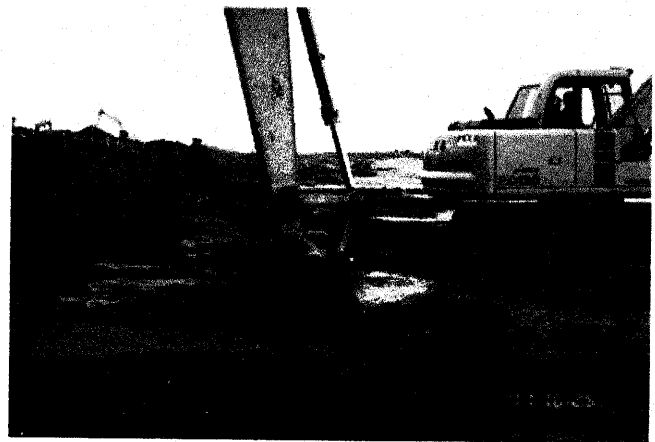
Fig 5. Recovery works done on the beach (1)
(Presented by Marine Disaster Prevention Center)

On January 7th, 1997, soon after the oil stranded on the beach, staff members of local society started to clean up the beached oil with more than 70 construction machines like power shovels. Because of the inability of the equipment to separate oil and sand, they ended up making over 18,000 m³ of oil mixed with sand. Some part of oiled sand was tried to sieve to get the tarred oil out by many volunteer workers but they could rid only 377 m³ of oiled sand (see Figure 5 and 6).

Oil recovery works using heavy machinery was done just along the line of pioneer plants (see figure 5 and 6 again). By these works, plant vegetation was totally destroyed. These pioneer plants have strong roles for the formation and stabilization of the sand beach. These plants trap and hold windblown sand in the foredune and help create condition with encourage the establishment and growth of other plant communities. All plants, whether they are herbs, shrubs or trees, growing either singly or in groups, have a role in the development of vegetative cover and together they bring about dune stabilization. Anyway, all was thought to be due to the recovery works done by heavy machinery.

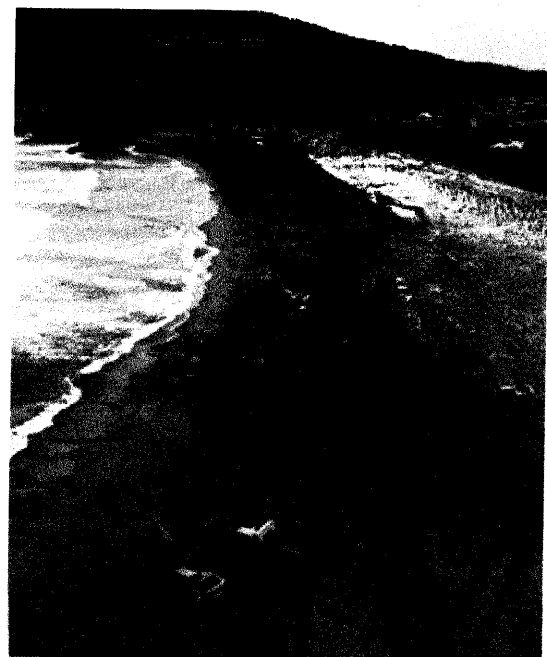
Fig 6. Recovery works done on the beach (2)
(Presented by Hokkoku Shinbun Co., Ltd.)

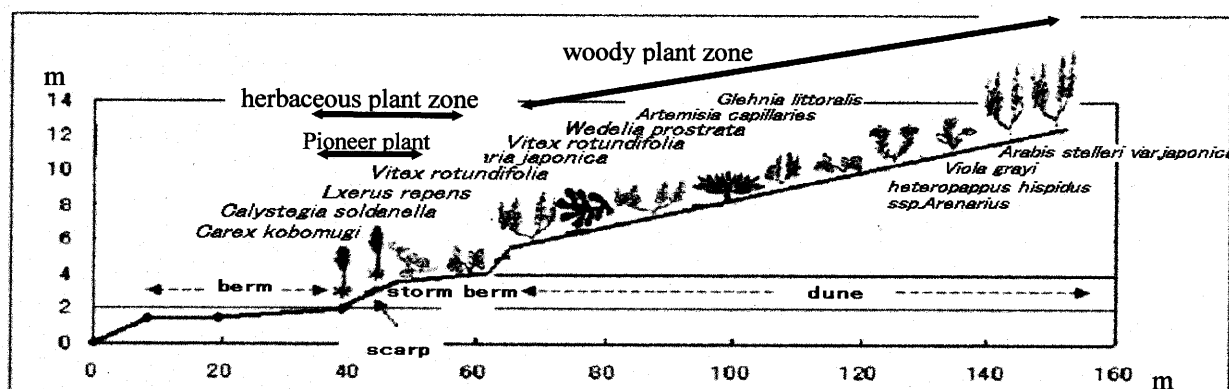
Fig. 7 Zonation for vertical section at Shioya and Katano before oil spill

Clear vegetative zonation along the vertical section can be seen on this beach. From the central part of the storm berm, we can see a few kinds of herbaceous plants such as Kobomugi (*Carex Kobomugi*) and Hamahirugao (*Calystegia soldanella*) as pioneer plants. Hamagou (*Vitex rotundifolia*), one of the nann-woody plants is dominated and covered with the rear part of storm berm to the hillside of the dune with high density. Upper part of the dune is covered with herbaceous plants again such as Isosumire (*Vila grayi*).

Figure 7 shows the schematic diagram of typical zonation before the oil spill and recovery works on this beach.

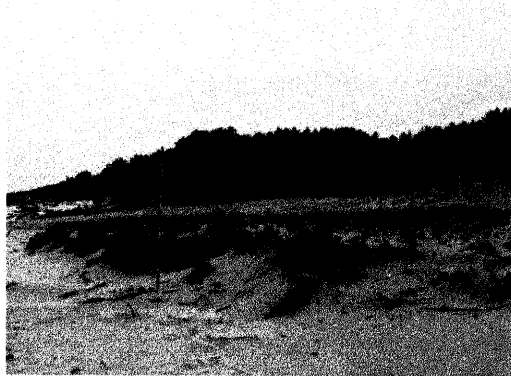
Fig. 8 Katano beach in September 1998

One year after the oil spill and recovery works, it appeared recession of the plant vegetation as well as the sand erosion of the berm. Figure 8 and 9 were taken at almost the same point and angle. Comparing with these two pictures, storm berms and plants were completely disappeared as of May 2001 at this area.

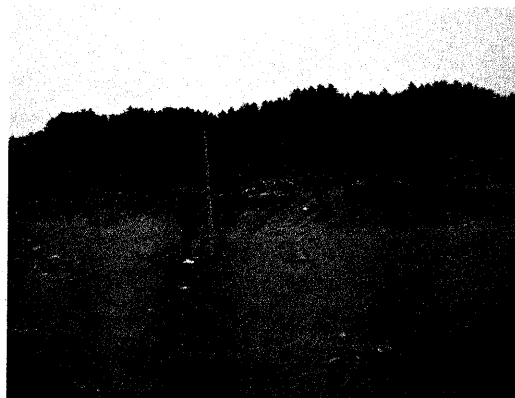
Fig. 9 May 2001 (Same angle as Fig.8)

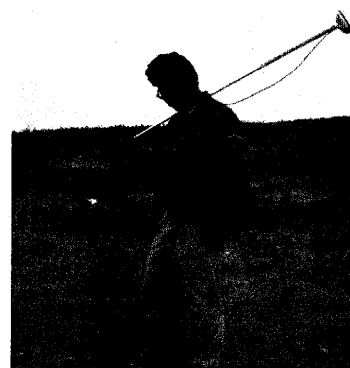
Fig. 10 On-site survey for measuring pioneer plants using dGPS

Carrying roving port of the system and data-logging computer on/along the target, positional information can be stored automatically. Positioning precisions come to be less than 1.0m (In the case of independent GPS, reliable precision is said to be about 10m). Figure 10. shows the actual scene of using this system for positioning the pioneer plants at Shioya beach.

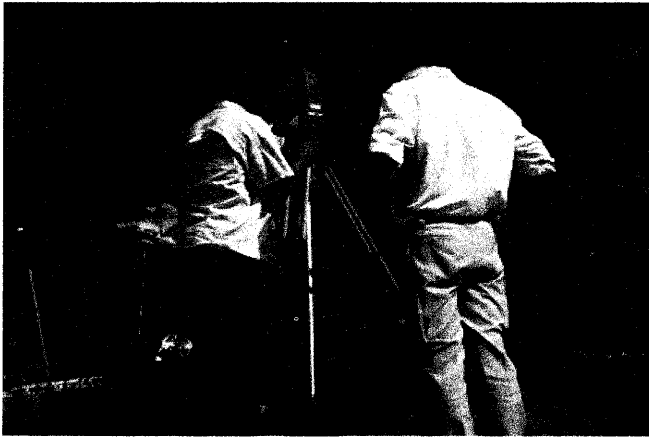
Fig. 11 Setting the base line using TS and stable land markers

In this survey, base line for the measurement is set by the stable reference points such as stone markers on the beach using Total Stations (TS). After the base line is fixed, measuring points are set along this line also using TS (see figure 11). Measuring points are set with 10m-grid interval, 100-150m along the strandline. For the vertical direction, the base line is also extended 40m toward the hillside of the dune. Total number of measuring point is 60 for Shioya, 40 for Katano. Precision for setting measuring point should be less than 1cm in each survey.

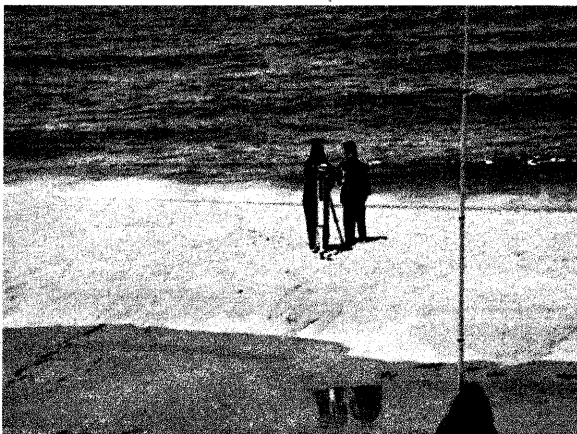
Fig. 12 Staff and level are used for measuring elevation

After all measuring points are fixed, elevation is measured at all these points by level and staff (see figure 12).

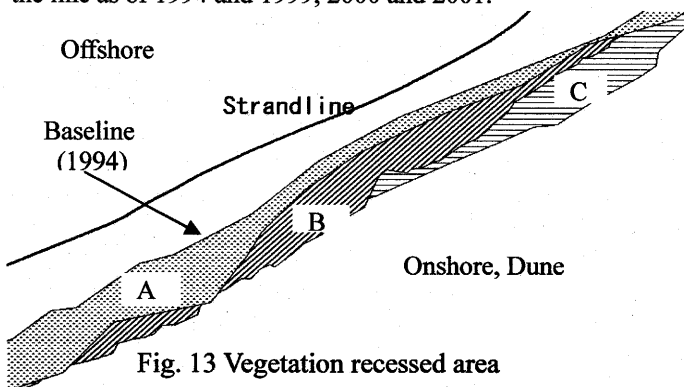
Fig. 13 Vegetation recessed area

In the figure 11, area A, B and C show the recessed vegetation area comparing with 1994 and 1999, 2000 and 2001 respectively. Figure 10 only shows the central part of this beach, then table 2 summarizes the areas progressed (moving toward the strandline) and recessed comparing with the line as of 1994 and 1999, 2000 and 2001.
